# Old Court House, Wollongong

## Conservation Management Plan 2021

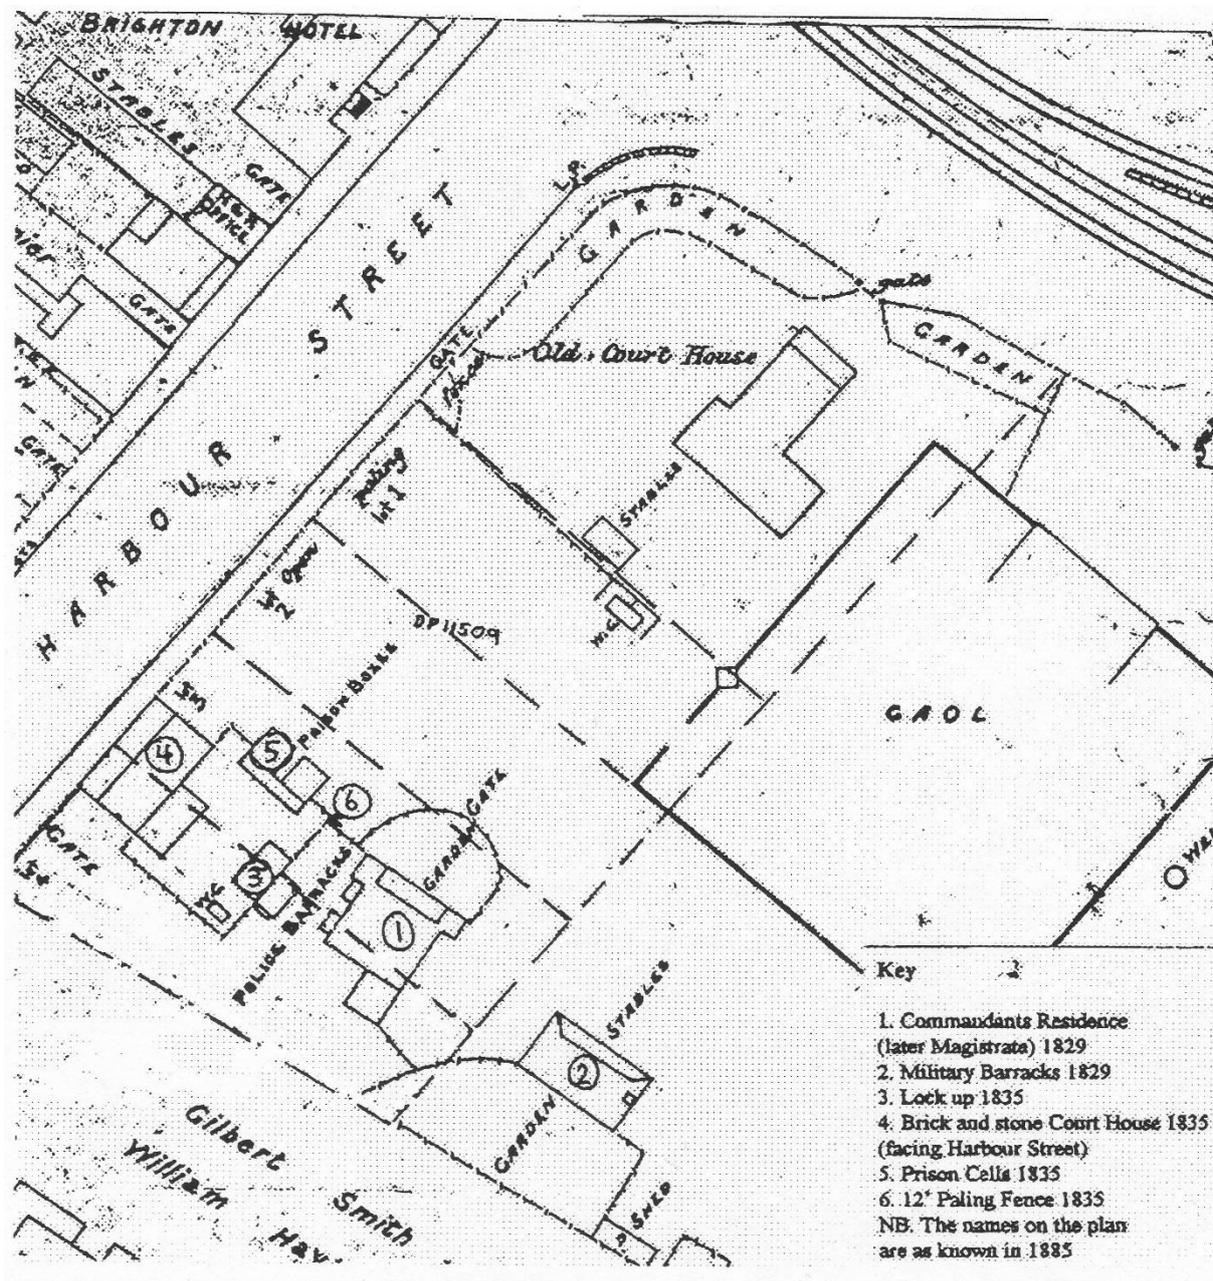
Figure 1. Extract from the 1887 Survey Map showing the buildings that were located on the Government Reserve on Harbour Street in 1885. The corner section including the Old Court House are all that remain.

The site is the only remaining section of the Government Reserve (refer Figure 1). The buildings and structures it included were part of government administration when the Town of Wollongong was centred on the harbour.

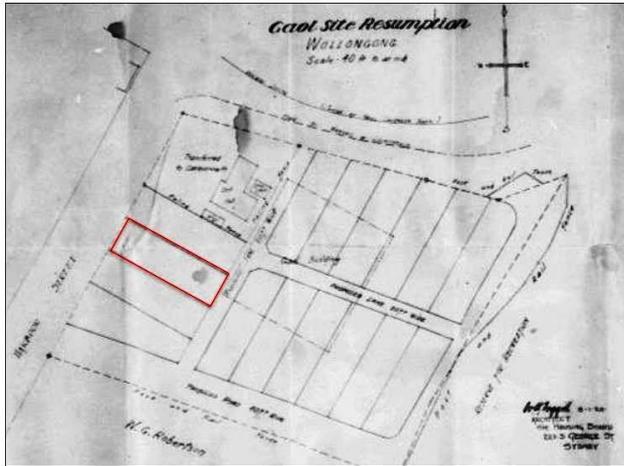
Figure 2. Subdivision Plan of 1920 showing the subdivided area and the corner part being the remaining part of the Government Reserve. Note the area marked in red – the site of the first Court House.

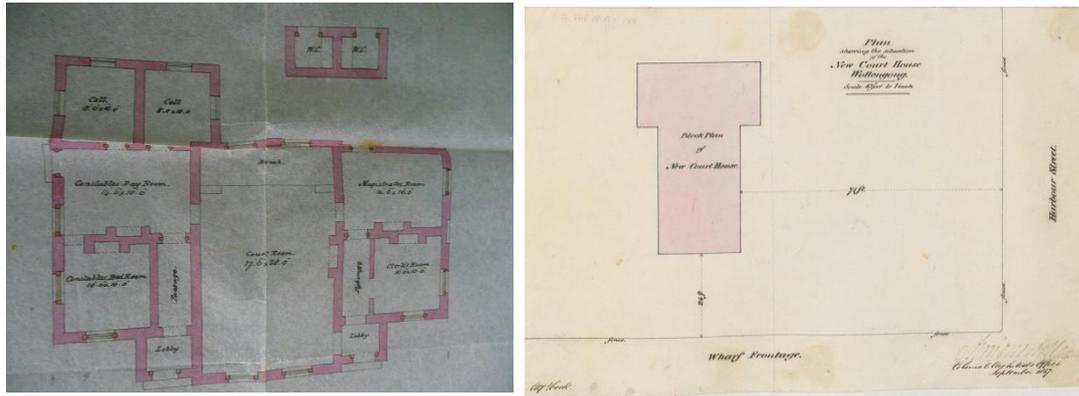
Figure 5. Colonial Architect plans – Original plan and elevations on the left and final, site plan only on the right

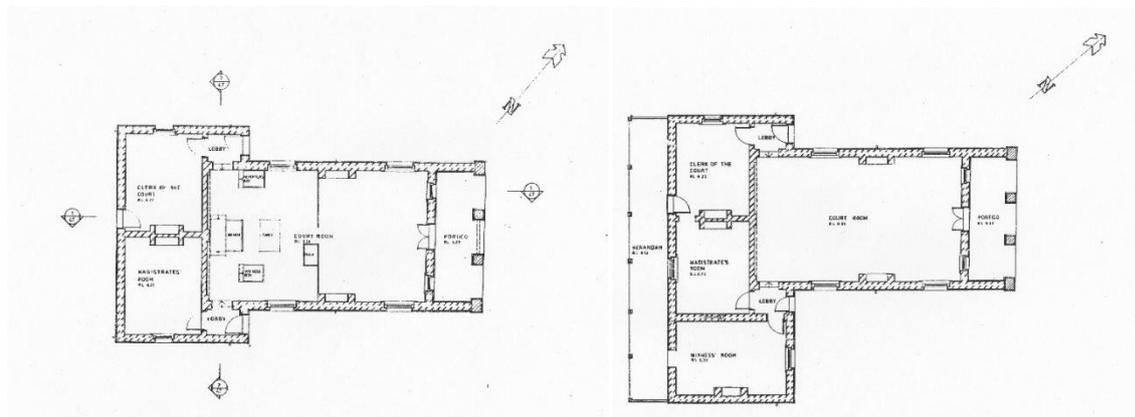
Figure 8. 1858 Court House as built on the left and addition of Witness Room on the right

A substantial change was requested in 1866 for **accommodation for witnesses** to enable them to wait under cover until called to give evidence (refer Figure 8). This addition saw a loss of architectural symmetry.

Note is also made of the **opening** between the Non-Commissioned Officer's (NCO) Room and the Officers Room (refer Figure 8, right hand plan, and Figure 11). No reference has been found of this opening being made or requested.

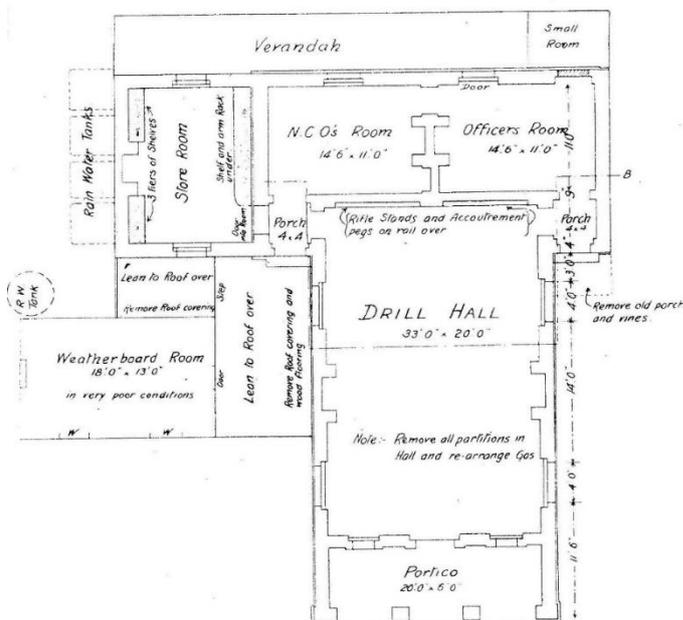
Figure 11. 1905 Plan showing existing fixtures and alterations to be made for the changeover to Drill Hall. Note - reference to "Remove lean to roof over and wood flooring"

The **former Weatherboard Custom House** was moved across the road to adjacent to the new Custom House in about 1887 and the chimney was rebuilt. Later during this structure's use as a bond store a raised timber walkway and lean to roof were built between the weatherboard bond store and the Custom House to facilitate weatherproof access to and from each building. Evidence of this was found on a plan that was prepared for alterations to fittings in the building to enable the changeover from Custom House to **Drill Hall** for the 4th Garrison Artillery (refer Figure 11).

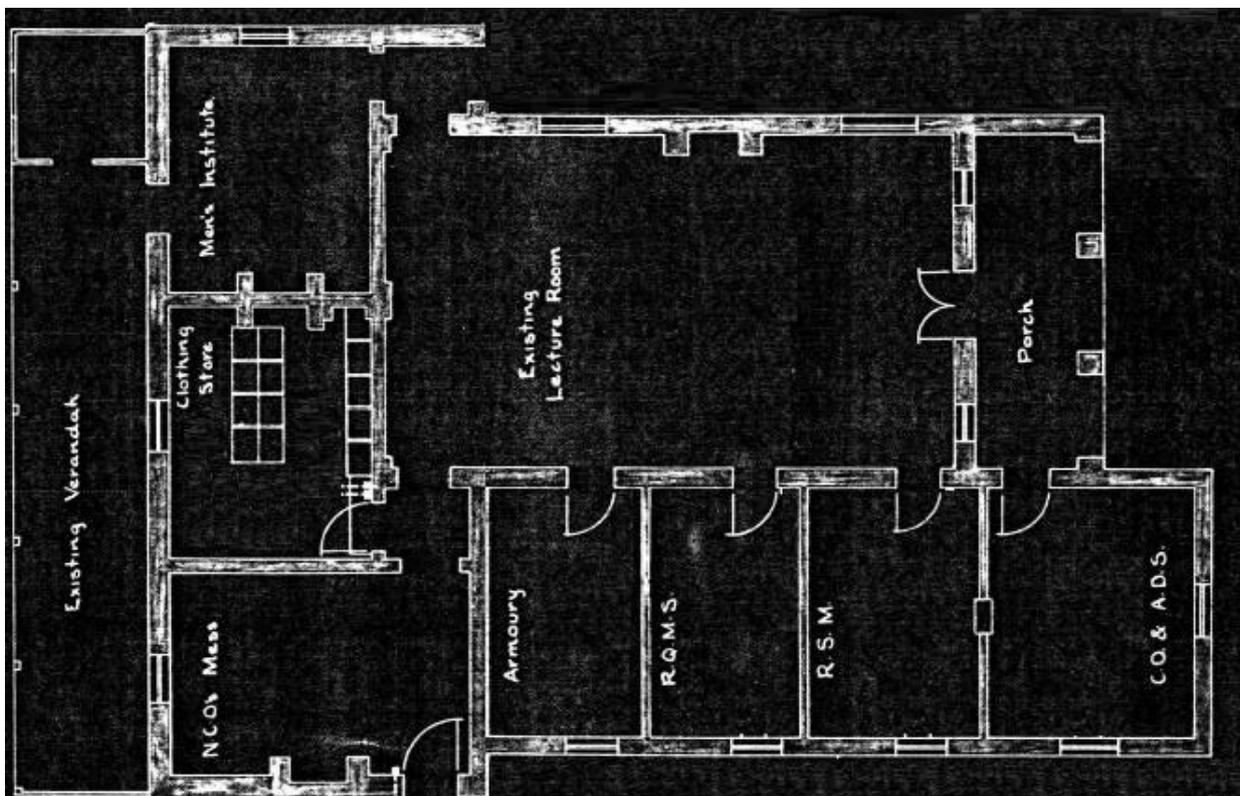
Figure 12. Plan showing the Drill Hall extensions of 1939 and the changes it generated to the former eastern wall, including fireplace and chimney, of the building that also necessitated the relocation of the weatherboard building.

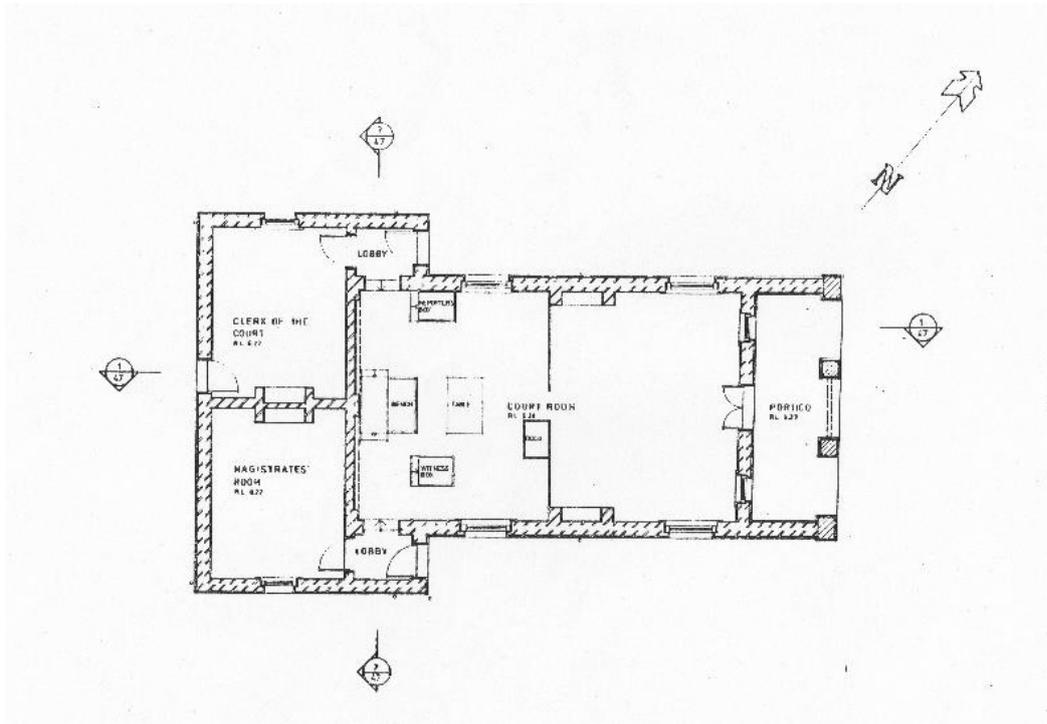
Figure 16. Original layout of Court House – 1858

**Clerk of the Court Room** is essentially the same in relation to layout and fire place.

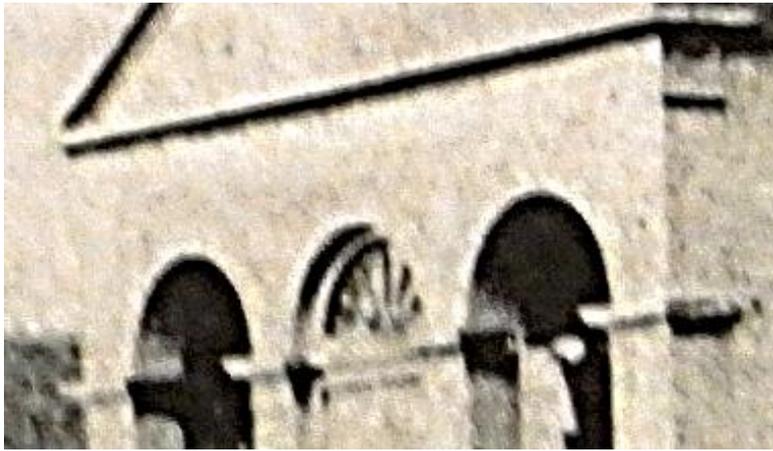
Figure 17. Extract from 1860s photograph of 1858 Court House showing Wrought Iron inset in centre arch.

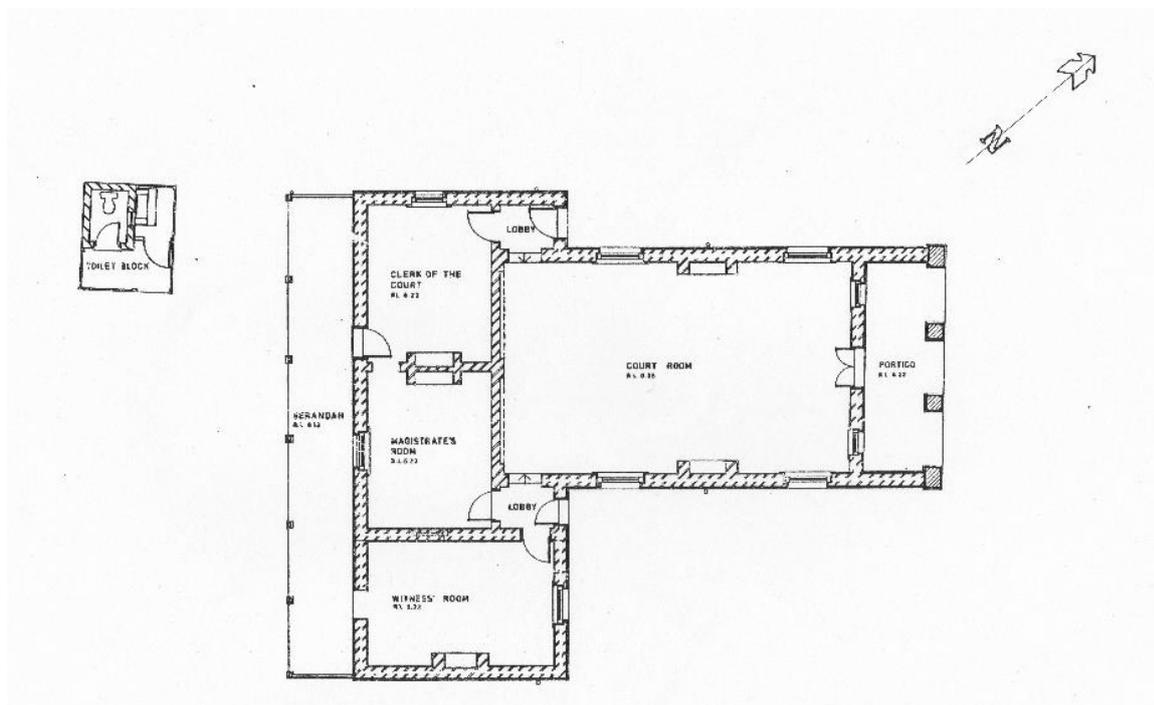
Figure 18. Addition of Witness Room, Verandah and Privy (toilet block) – circa 1866

**Clerk of the Court Room** had an opening created on the southern end of the wall between it and the Magistrates Room.

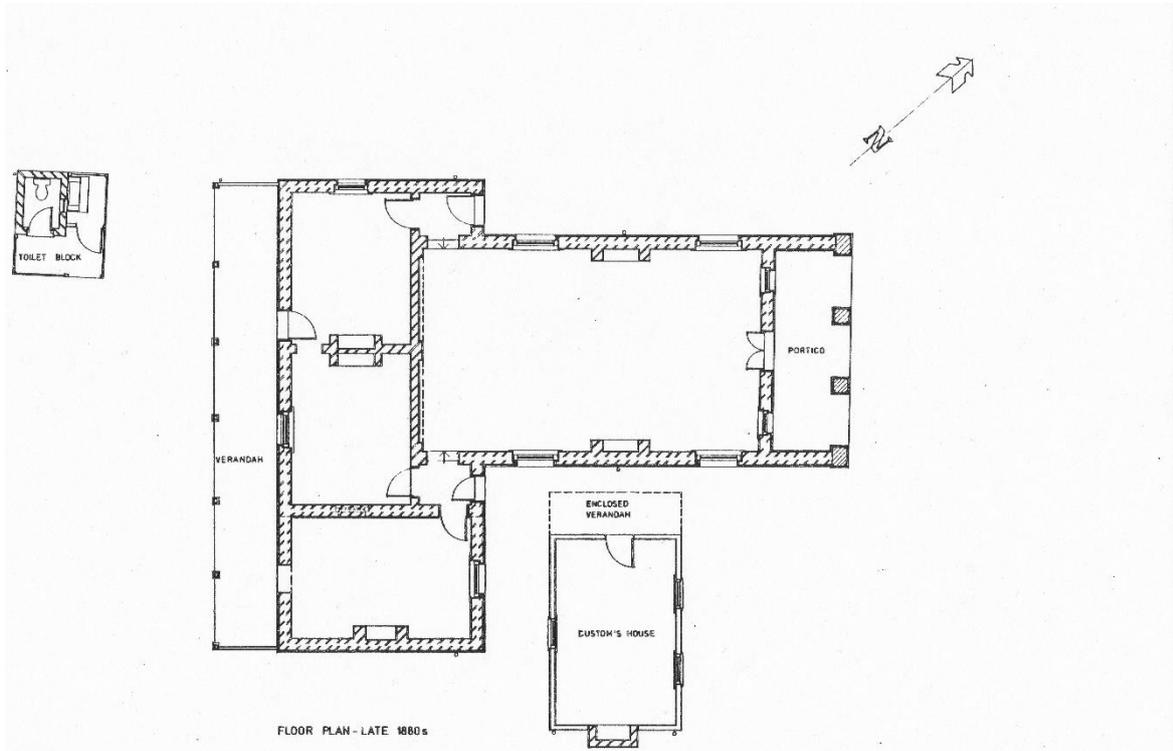
Figure 19. Change to the Custom House – 1885 and movement of Customs Office from Brighton Lawn – 1887

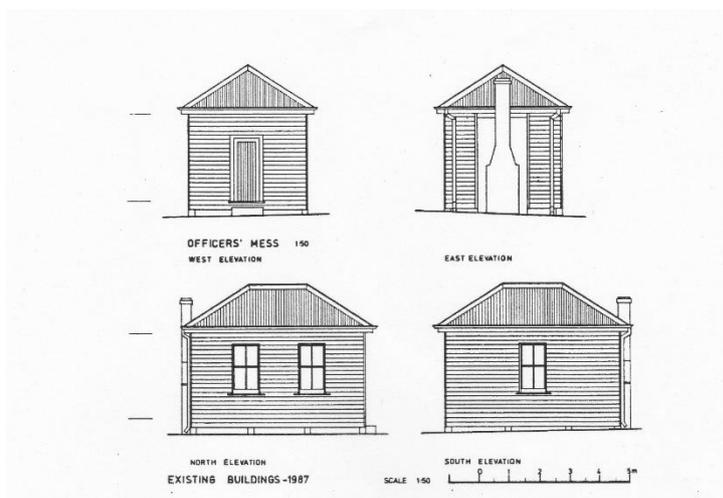
Figure 20. Elevations of the former Brighton Lawn Weatherboard Custom House. Note verandah not included.

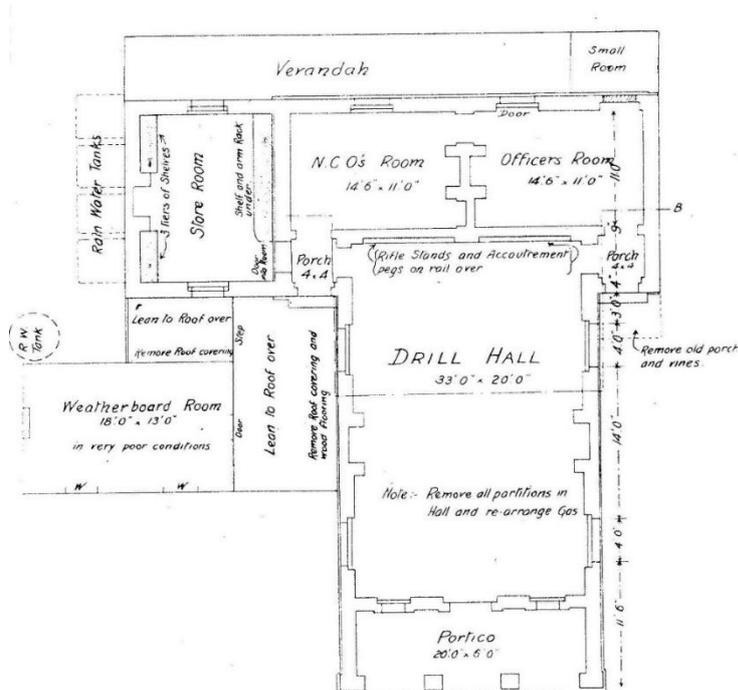
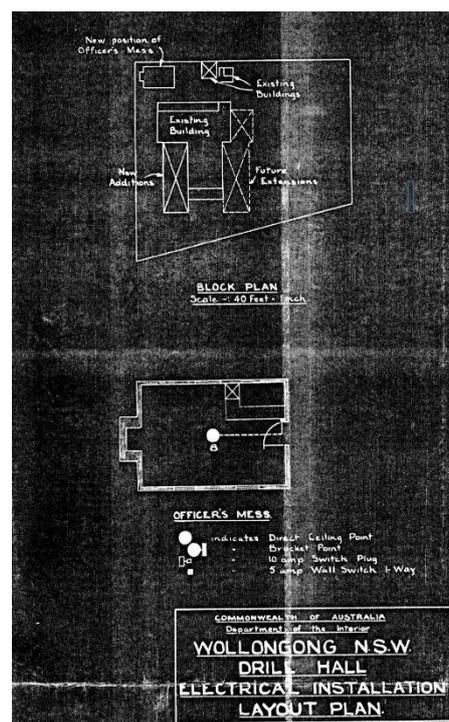
Figure 21. Left - Changes made to the former Custom House to become Drill Hall for 4th Garrison Artillery – 1905  
Right – Drill Hall Electrical Installation Layout Plan – Officer’s Mess – May 1939

No reference has been found of the small weather board building, other than “Weatherboard Room” in Figure 21, Left, between 1905 and 1939. The earliest plan showing any interior fixtures has been the 1939 Electrical Installation Layout Plan (refer Figure 21, Right) which showed in the Officers Mess a partition and fixture on the right of the doorway. The 1939 Specification of Work referred to the above Officer’s Mess as “Sergeants Mess”.

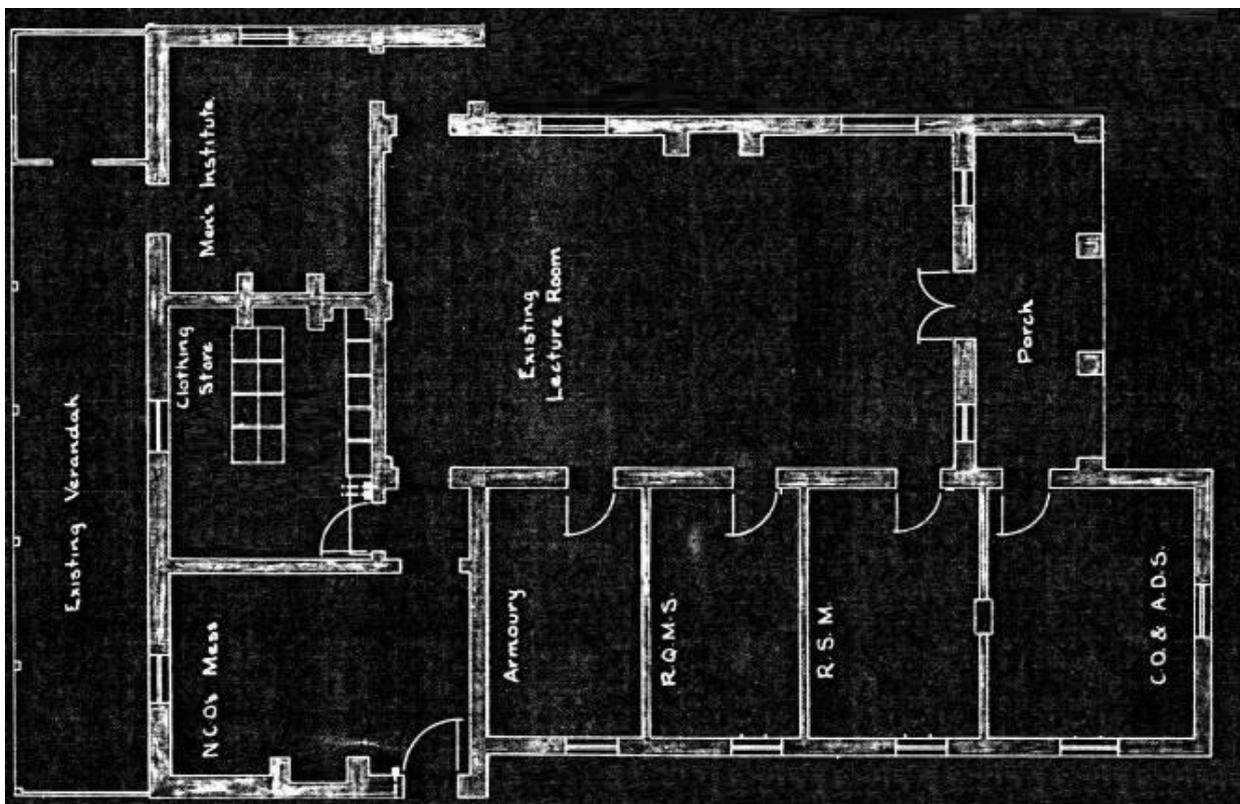
- **Four rooms were added** on the eastern side of the building forward of the lobby to the Clothing Store and NCOs Mess.
- **Three windows (2 long and one small)** built in wall above doors to three southern rooms and roof to four new rooms.
- The **former doorway** to the outside from that porch was bricked in.
- The former **window in the northern wall was bricked in** of the NCOs Mess.
- A **doorway was added** in the eastern wall of the NCOs Mess
- The **lining of the verandah** was specified to be replaced
- **Small room in verandah** appears to have reduced in size
- **Clothing Store** had shelving added
- **The floor** where the eastern fireplace was changed to timber
- **The northern two new rooms** had an opening between them

Figure 22. Additions and alterations prior to World War II - 1939

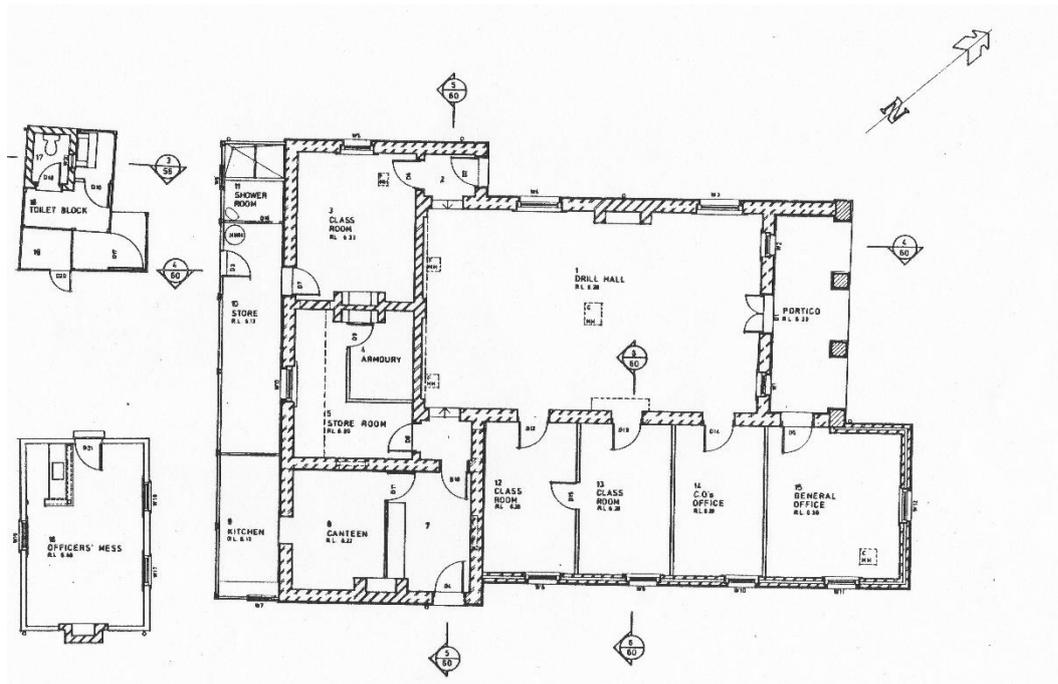
Figure 23. Site layout including alterations to the drill hall - 1939

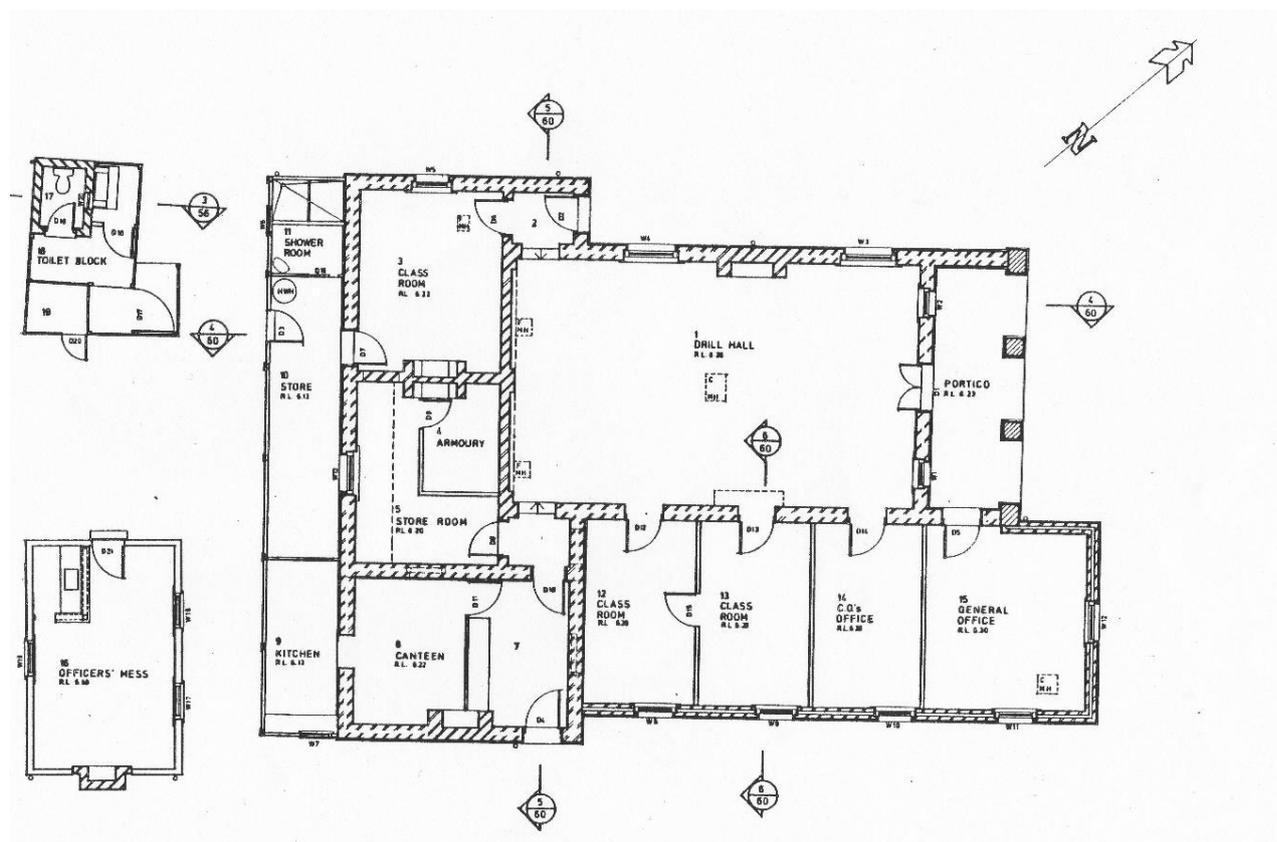
The following plan was provided to show the room numbering outlined in the above Conservation works.

Figure 25. Floor plan - Proposed Conservation Works and New Use (Dwg. 18 of page 98 of the EC & CM Jones Report 1987)

The layout, including fittings and fixtures, of the building shown in the ME & CM Jones Report plan in Figure 25 differed from that which existed at the start of the Restoration. The plan in Figure 43 shows the layout and fixtures that were in existence at the start of the Restoration.

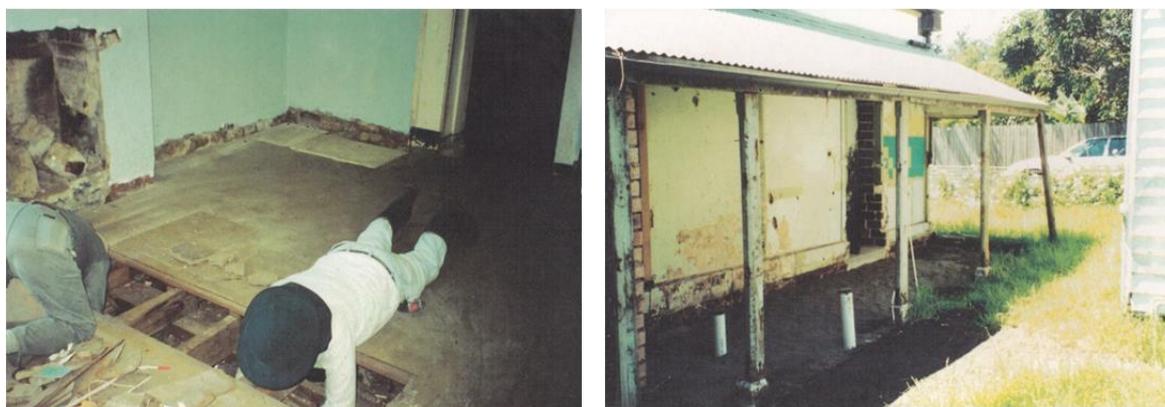
Figure 26. Left - former Witness Room - floor, fireplace, etc; Right - Rear Verandah – supports, no floor & walls

Former **Court House era Magistrates, Witness and Clerk of the Court Rooms** were also in a bad state of repair as the example photograph shows in Figure 26, Left. The work performed included the following:

- Remove fixtures of the Naval Cadet use to return them to 1858-66 dimensions, etc
- Repair of floor joists and bearers
- Repair to floor boards
- Replacement of skirtings, architraves and door frames
- Repair fireplace and replace timber work on and mantelpiece.
- Repairs to wall rendering
- Painting

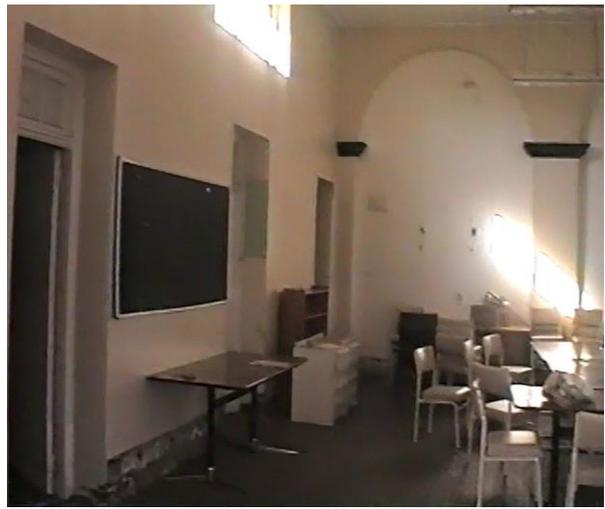
Right former court room - SE view

The **former Court Room** was also in poor condition as Figures 27, Right; 28, Right and Left and 30, Right clearly show.

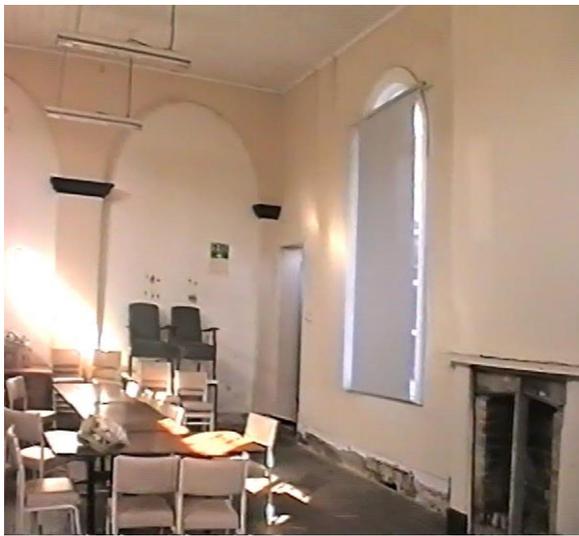
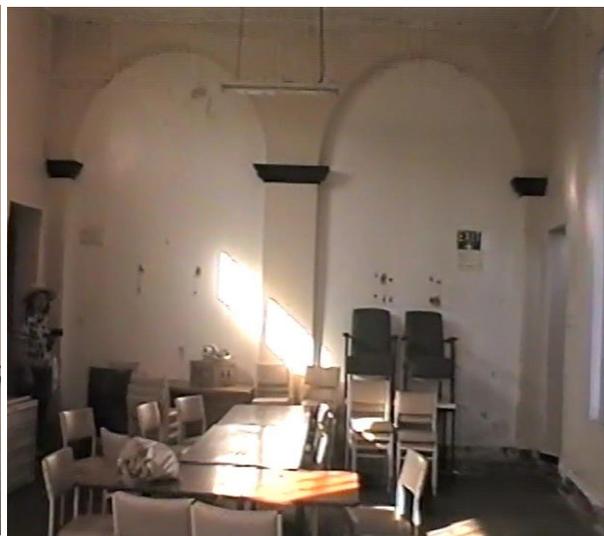
Figure 28. Left - former court room - SW view.

Right - former court room - South view

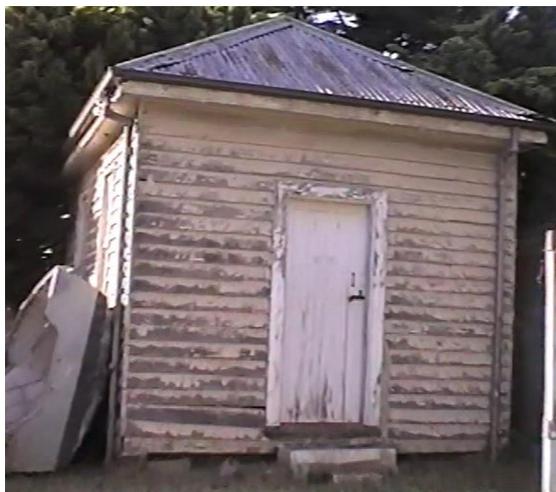
Figure 29. Left - old Weatherboard Customs House.

The former **Weatherboard Custom House**, as shown in Figure 29, Left also required extensive repairs to:

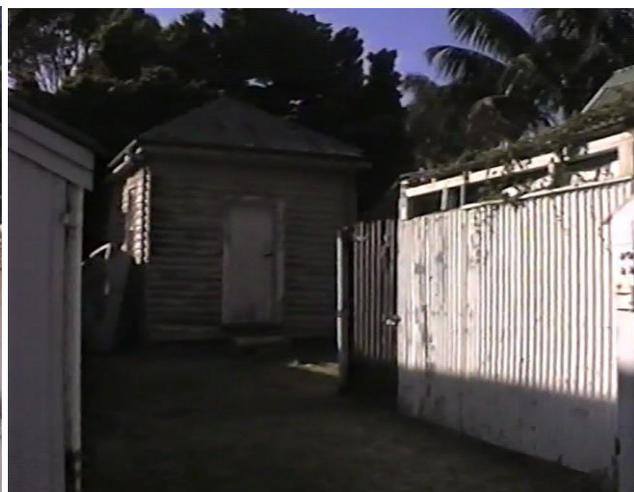
Right - 1890 Privy and Weatherboard Custom House

The **1890 Privy**, as shown in Figure 29, Right, required extensive cleaning up and repairs including:

- Repairs to walls and roofing
- Repairs to toilet and urinal and plumbing
- Capping of concrete floor
- Painting

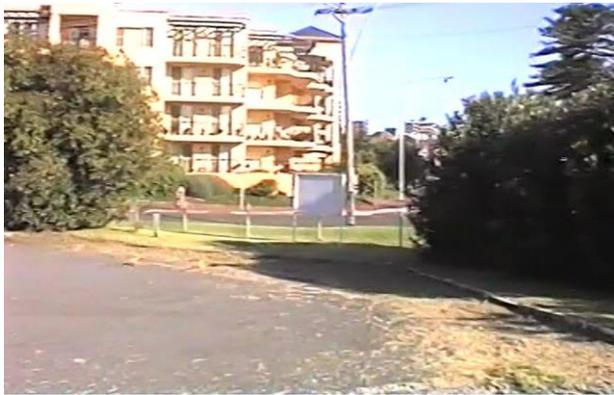
Figure 30. Left - Car park looking north from main building

The yard was majority car park was considerably overgrown as partially shown in Figure 30, Left.

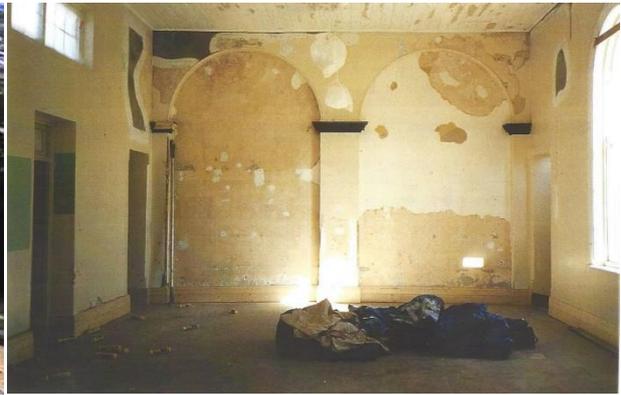
Right – Main Hall looking south

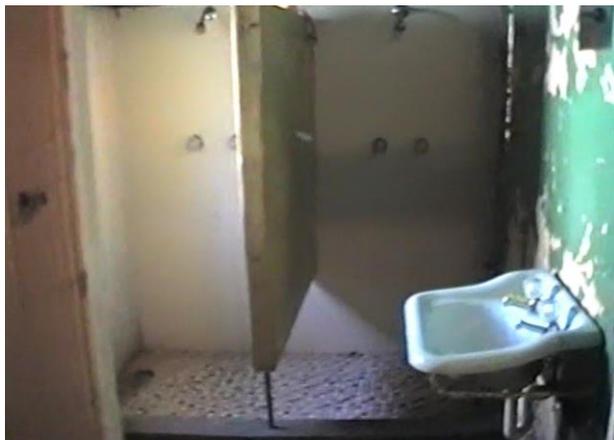
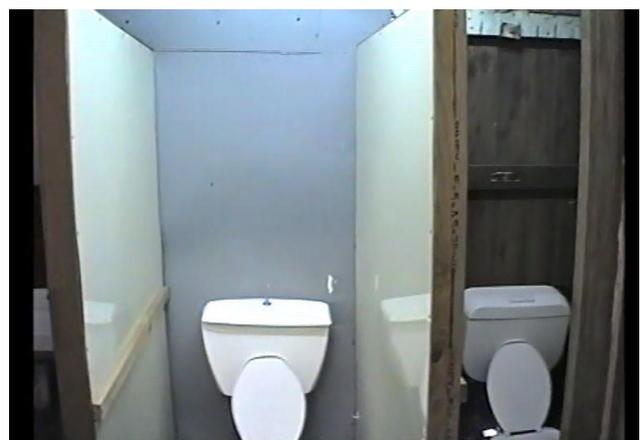
Figure 31. SW section of verandah. Left – Shower facilities.

Right - toilet facilities

Circa **1870-1890 verandah** required major work as the state of disrepair in the right side of Figures 26, Right and 31 shows. The work performed included the following

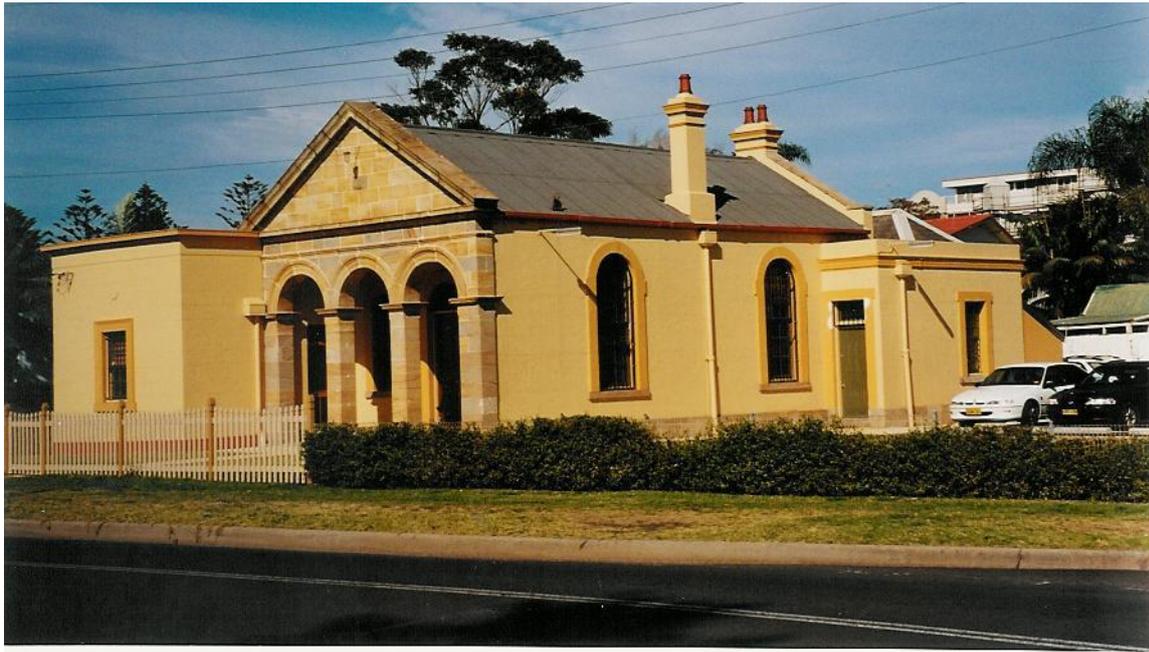
Figure 33. Exterior view of new finished restoration showing colour scheme, picket fence and plumbago hedge and reduced size car park and 1890 Privy behind.

- Planting of pumbago hedge along boundary fences on north western, western and eastern boundaries to replace the rusted wire mesh fence (the original post and rail fence was considered out of character today).
- Picket fence on a splay to front boundary
- Gravel finish between verandah, 1890 Privy and Weatherboard Custom House

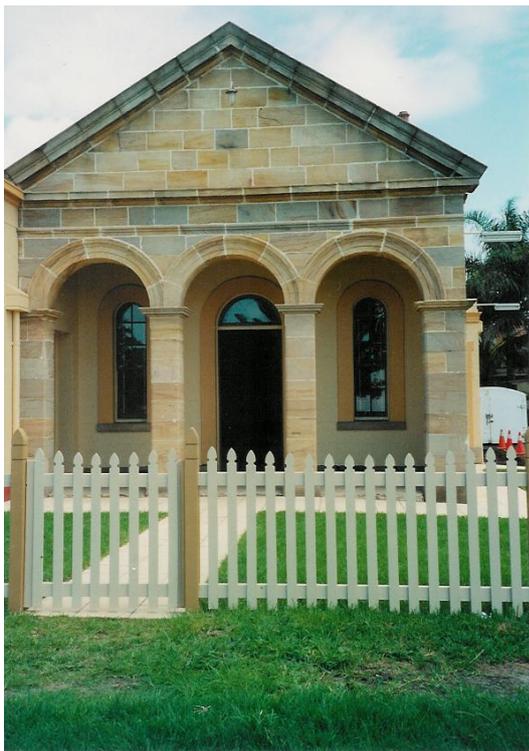
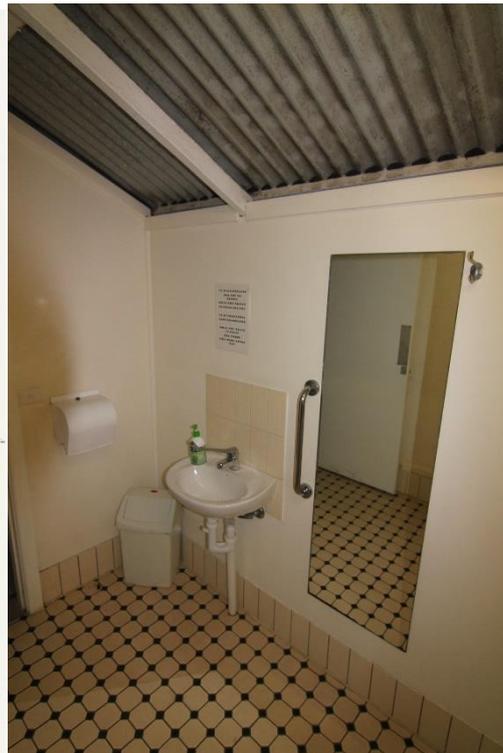
Figure 34. Left - Portico, paths, lawn and picket fence. Right – New toilet facilities in verandah

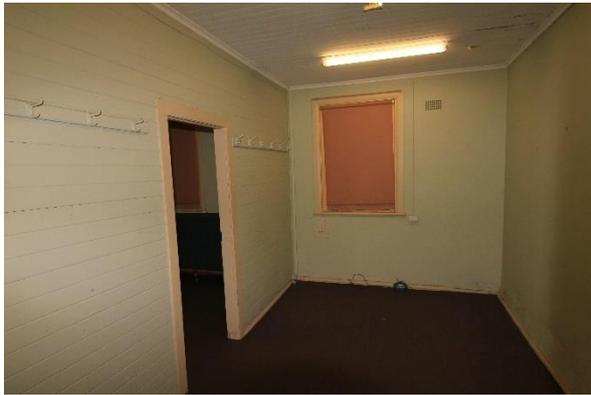
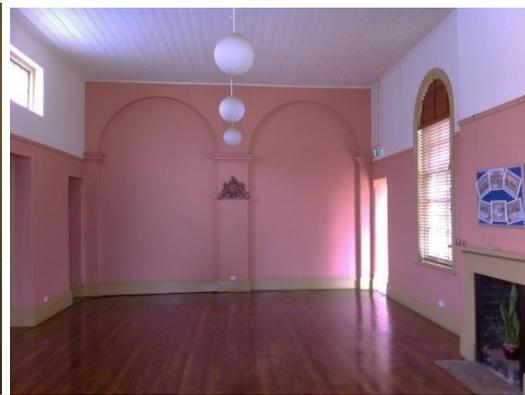
Figure 35. Left - Southern of the 1939 rooms.

Right - Main Hall

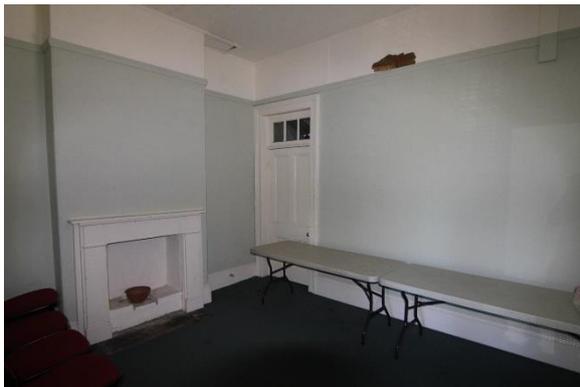
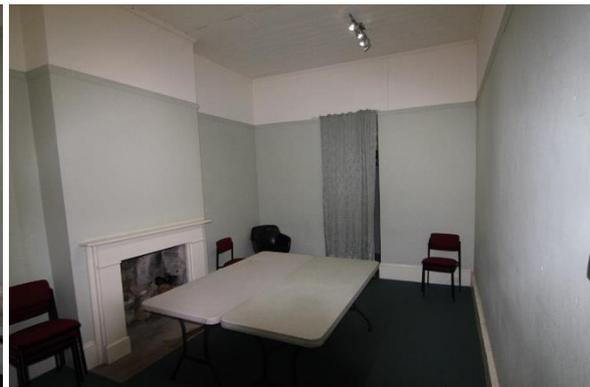
Figure 36. Left - former Clerk of the Court room.

Right - former Witness room.

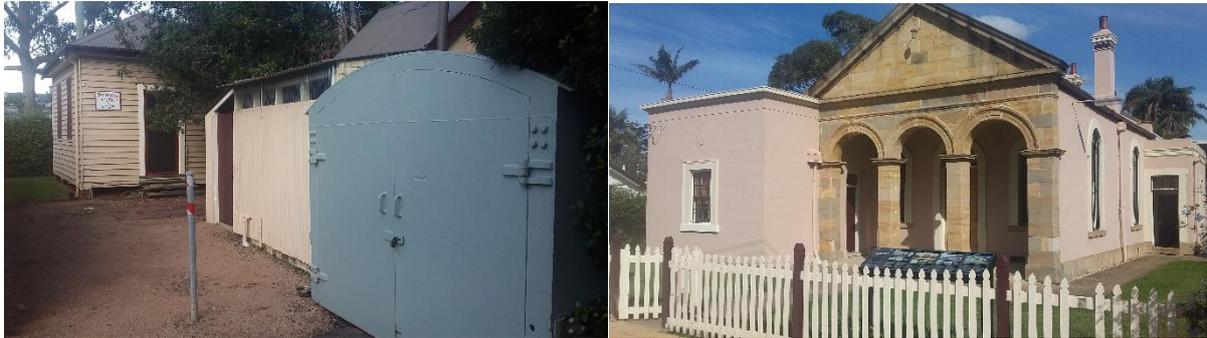
Figure 37. Left – Repainted former Weatherboard Custom House, Privy and Magazine. Right – Repainted Main building including Portico

The repainting in of the buildings, etc in 2016 and 2019, referred to in the above timeline, were undertaken after research and investigations determined what the original colours used in the Court House, Custom House, Drill Hall and Naval Cadet components of the precinct.

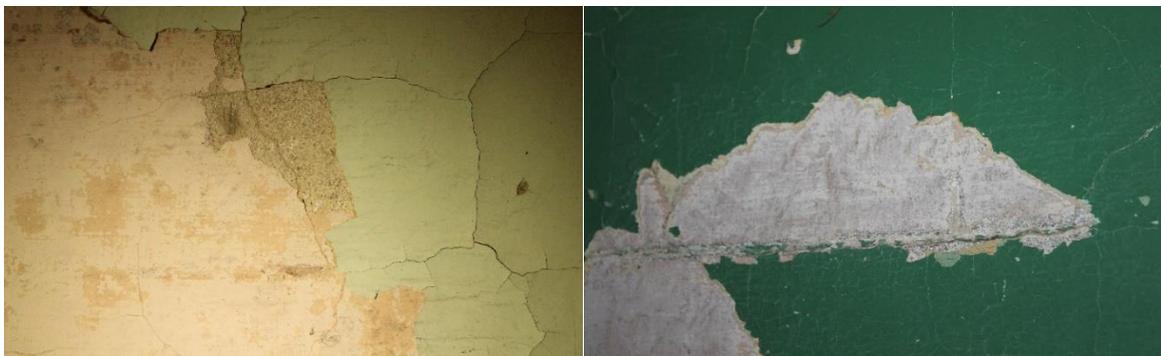
Figure 38. Sections of various earlier paint layers preserved on original back wall of 1858-66 Court House (inside verandah)

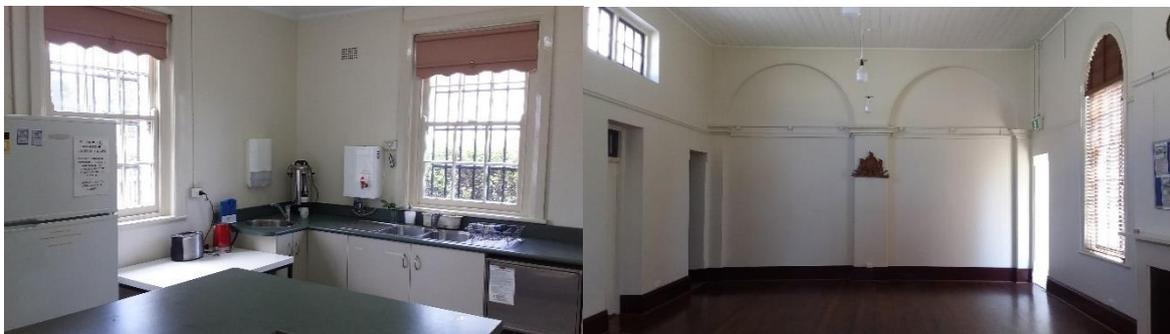
Figure 39. Repainted Kitchen

Right – Repainted former Court Room

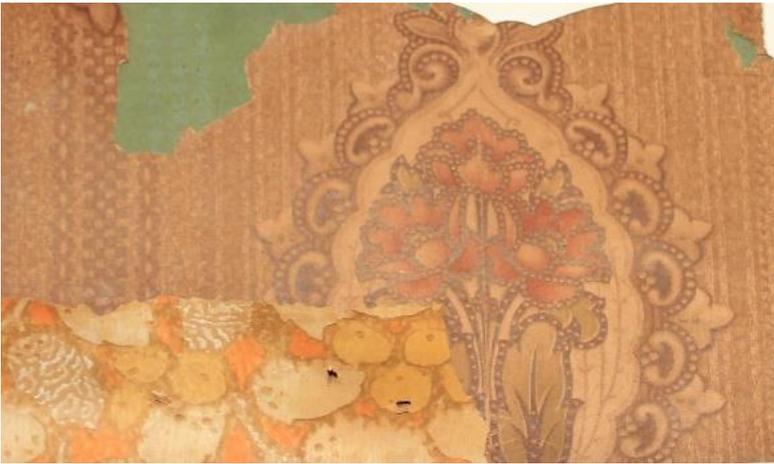
Figure 41. Preserved early wall papers - Clerk of Court room

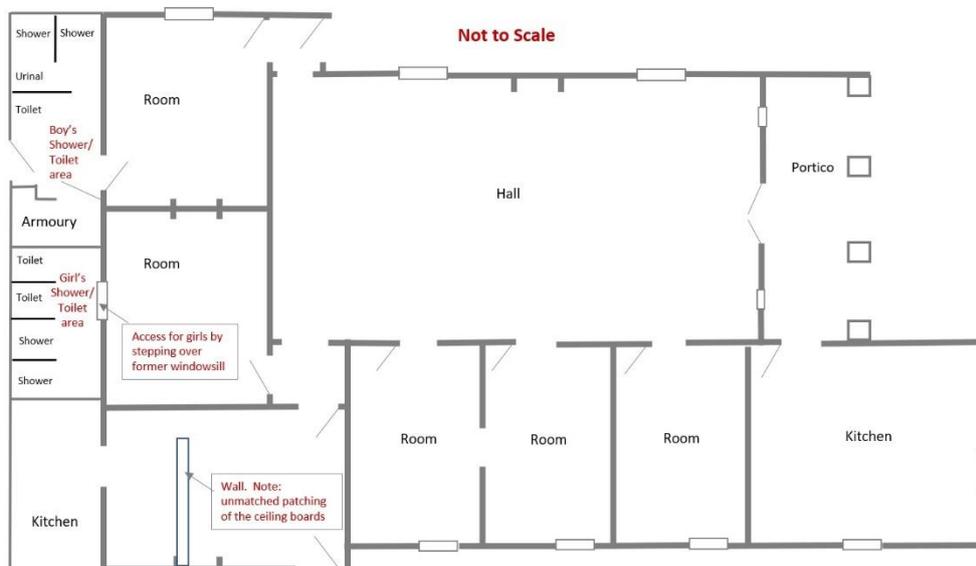
Figure 43. Plan of the layout of the building at the start of the restoration work in 1999. Drawn by author from the volunteers undertaking the restoration and pre restoration photographs.
